## Safety Bulletin の掲載について

## Safety risks of lifting slings encased in plastic sheathing on freefall lifeboats

## Safety of pilots boarding ships with pilot transfer arrangements that use non-approved methods to secure pilot ladders

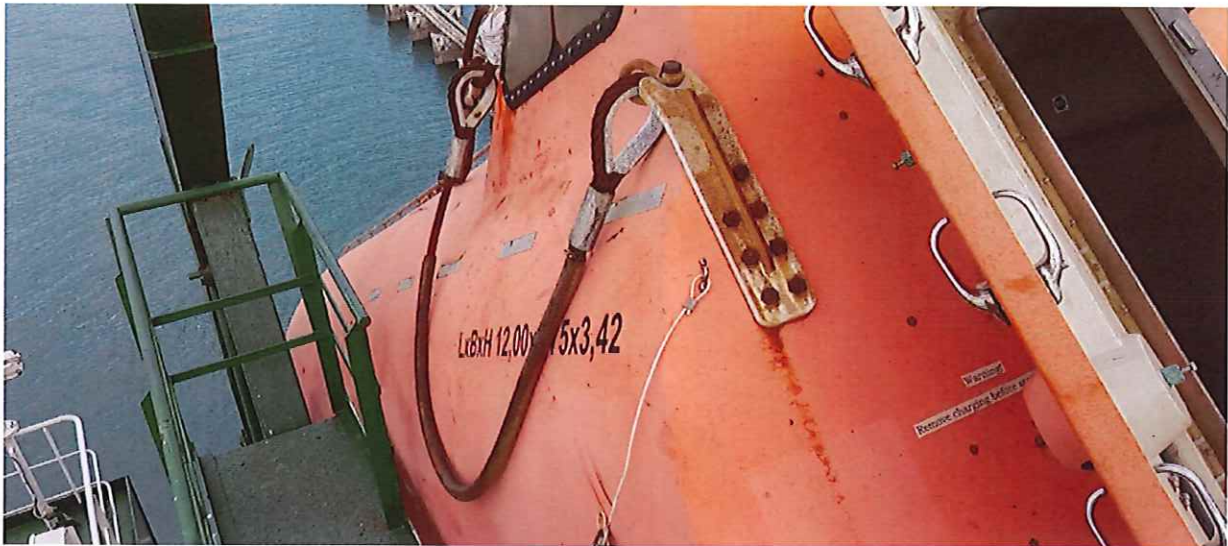
Figure 1. Lifting sling encased in plastic sheathing

Such arrangements have been found to restrict visual inspection of the wire ropes enclosed within and furthermore, prevent routine maintenance and survey being effectively carried out. As a result, the wire ropes may be seriously corroded due to passage of moisture/air inside and yet go undetected.

1. Masters and senior officers should physically check if freefall lifeboat lifting slings are encased in plastic sheathing.
2. Masters, senior officers and surveyors should physically inspect the sling for signs of corrosion beneath the sheathing.
3. Companies should consider means to ensure the inspection of slings encased in plastic sheathing and the risks posed by them is appropriately captured by their safety management system.
4. Consideration should be given to the use of slings without a plastic sheath, or an alternative method of encasing the sheath which allows for removal for inspection. Operators may wish to contact the lifeboat manufacturer for guidance in this regard.
5. Companies should ensure that the slings are renewed on a regular basis, using the same principle of maintenance of lifeboat falls as stipulated in SOLAS Chapter III, Regulation 20.4.

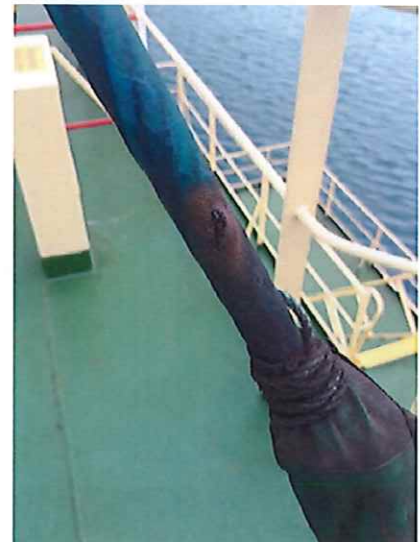
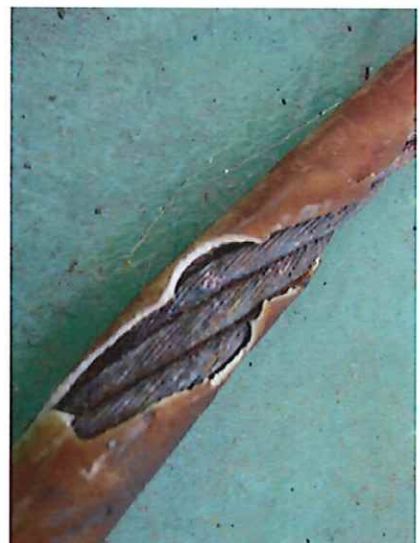
Investigations into the failure of the slings revealed that the slings parted under normal operational load due to significant weakening, as a result of internal corrosion. The internal corrosion within the sheathing went undetected, even though regular inspections were reportedly being carried out, as required by SOLAS Chapter III, Regulation 20 (Operational readiness, maintenance and inspections).

Figure 2. Corrosion beneath plastic sheathing.

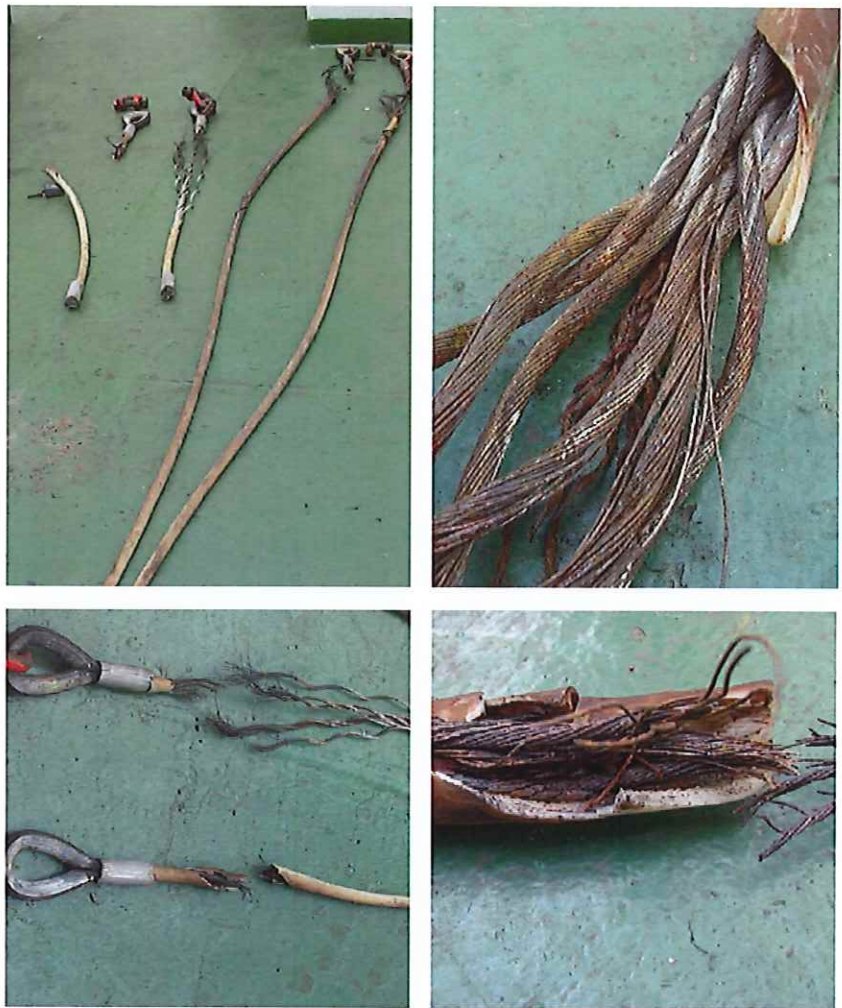
Serious incidents have occurred during launching and retrieval of freefall lifeboats using the secondary means of launching and retrieval with purpose built lifting slings encased in plastic sheathing. The slings have parted resulting in the freefall lifeboat plunging several meters into the sea with crew inside.

Figure 3. Lifting slings parted due to undetected corrosion.

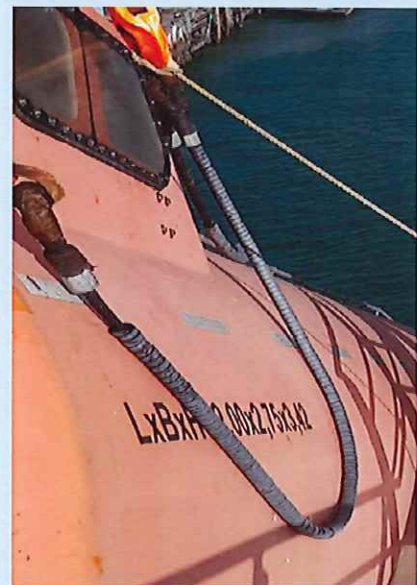
Figure 4. Alternative sheathing arrangement which allows for inspection

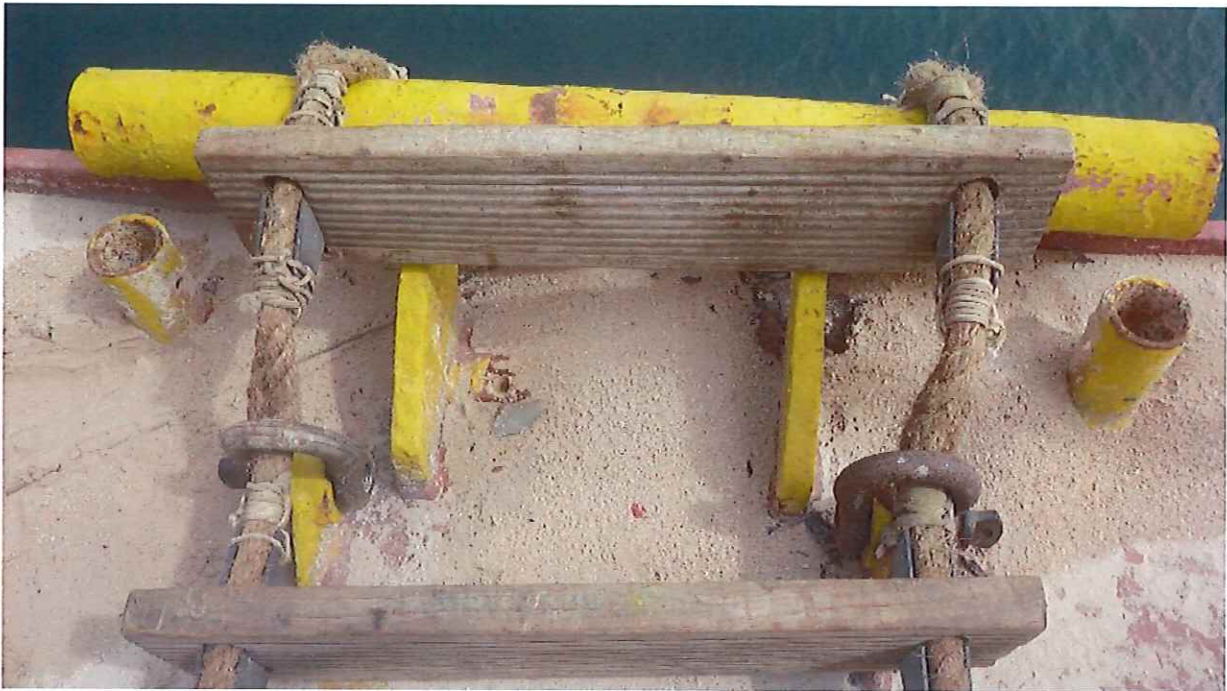
Figure 1. Pilot ladder incorrectly secured to the deck using D-shackles to choke the side ropes.

A large number of reports relate to the use of pilot ladders which are too long relative to the vessel's draughts. As a result the excessively long ladders require shortening up before being deployed for boarding pilots. In these cases, pilot ladders are shortened up by ship's staff using D-shackles to choke the side ropes at the required height along the ladder's length.

1. Masters and senior officer should physically check the current method of securing their vessel's pilot ladders to ensure that crews are not making this rigging mistake.
2. Refer to the ship's construction drawings to ensure that the actual securing method is the same as the method given in the ship's drawings, or approved safety management system.
3. To avoid vessels being delayed in port, where existing pilot ladders are too long for the expected range of freeboards, Masters must find an appropriate safe method for securing the ladder at the rope-end thimbles. If the existing arrangement cannot be shortened correctly, then masters should consider contacting their local port agent to obtain a shorter ladder for use a required.
4. In summary, you cannot rig your ladder safely if it is too long for your vessel's freeboard.

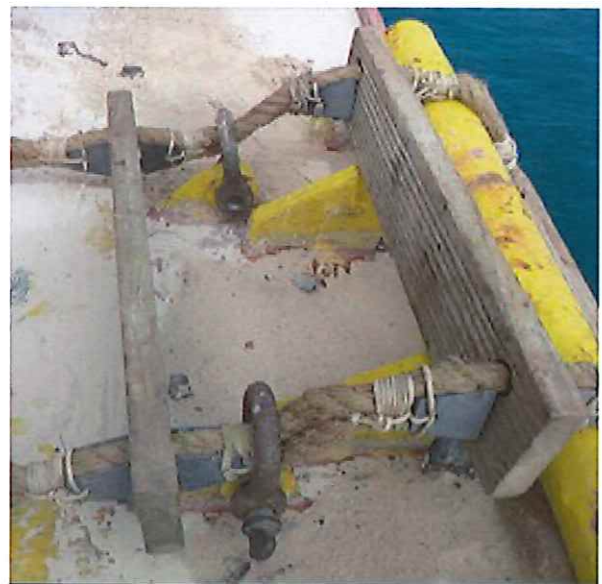
In this method, the D-shackle is first secured to a hard point on the deck, such as a pad eye, and the ladder rope threaded through the shackle. By shortening ladders using the D-shackle method causes the weight of the ladder to be taken up by the D-shackle impacting directly against the mechanical securing clamps (widgets) which secure the ladders treads in place.

Figure 2. Pilot ladder incorrectly secured to the deck using D-shackles to choke the side ropes.

Using D-shackles to choke pilot ladder side ropes can eventually damage these widgets and also destroys their seizing. When the seizing is destroyed, or the widget is damaged, this can lead to adjacent tread becoming loose

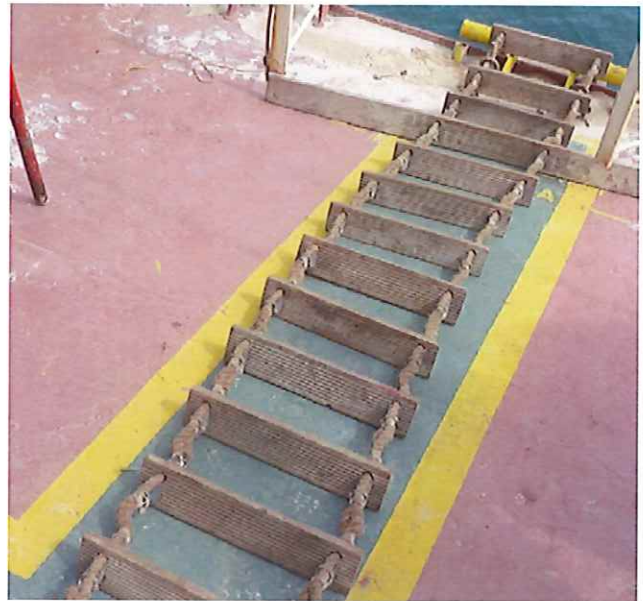
Figure 3. This ladder is too long for the freeboard.

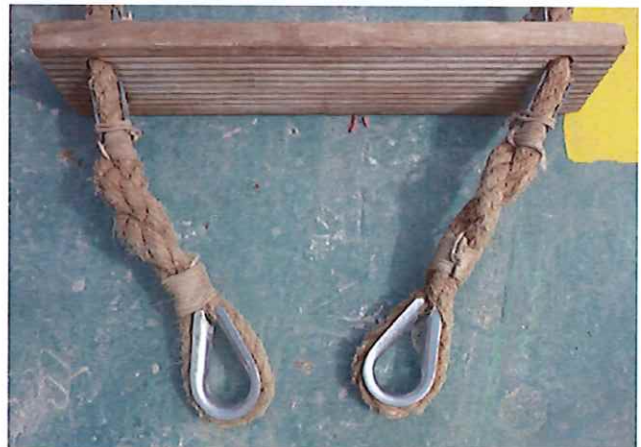
Figure 4. Pilot ladders are required to be provided at the rope ends with strong thimbles for securing the ladder.
